ROOM SEAL ADJUSTMENT INSTRUCTIONS

The HWH SpaceMaker®: Dual Cylinder "LATERAL ARM" Room Extension

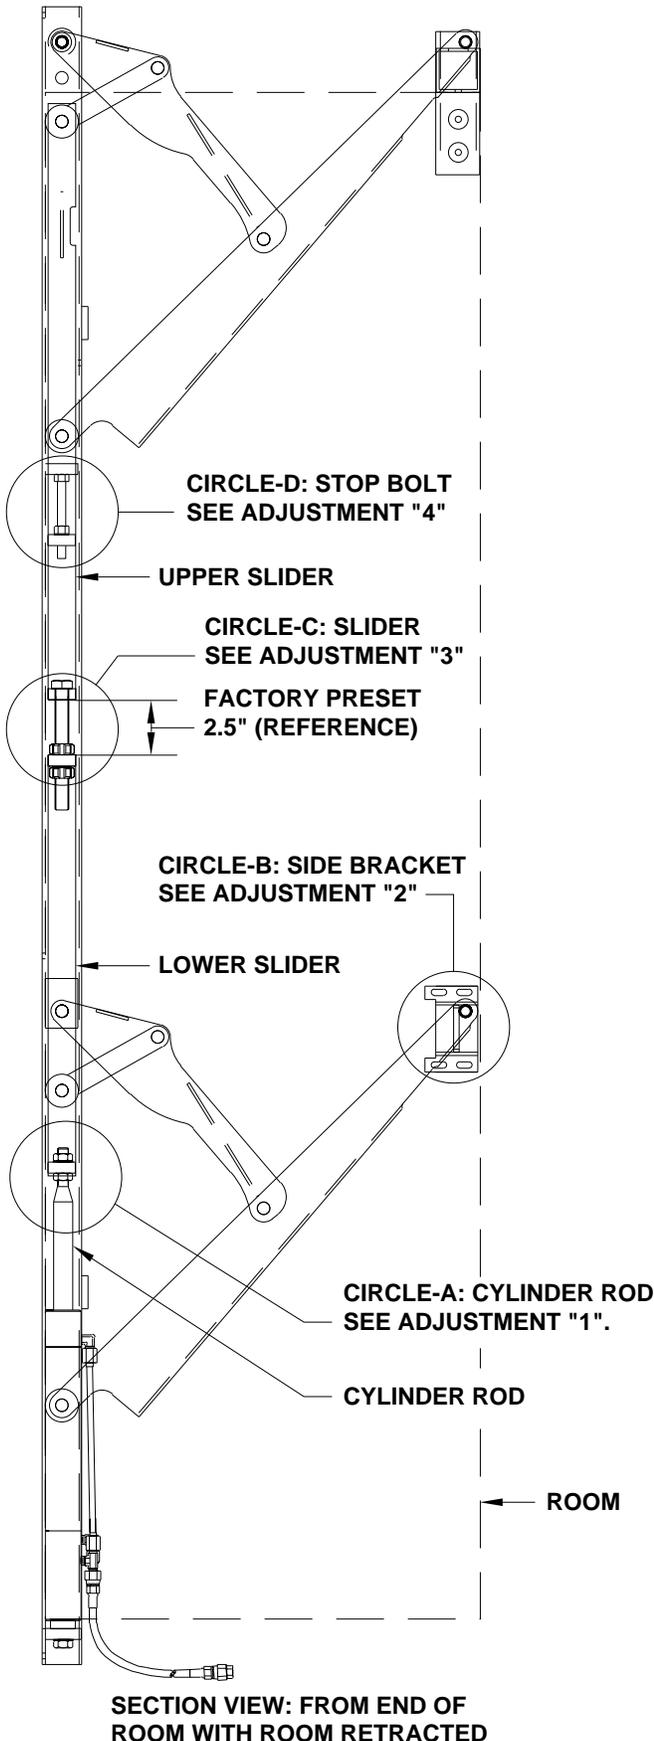
1. Problem - With the room extended both top and bottom do not seal: If gap between sealing surfaces is equal from top to bottom a CYLINDER ROD ADJUSTMENT is needed (See Circle A). Adjust both front and rear ROD assemblies as needed for a seal from top to bottom on both front and rear surfaces.

If the gap is not equal from top to bottom attempt to equalize the gap by adjusting the SIDE BRACKETS (See Circle B) before making a CYLINDER ROD ADJUSTMENT.

2. Problem - With the room extended the bottom of the room does not seal: First adjust the front or rear SIDE BRACKETS (See Circle B) as needed to close the mating surface gap. Close the gap as much as this adjustment will allow for. If a gap is still present a SLIDER ADJUSTMENT is needed (See Circle C). Increase the gap between the upper and lower sliders in 1/8" increments and re-test DO NOT exceed the factory preset gap by more than 1/4" wider or narrower, contact HWH Customer Service.

3. Problem - With the room extended the top of the room does not seal: A SLIDER ADJUSTMENT is needed (See Circle C). Decrease the gap between the upper and lower sliders in 1/8" increments and re-test. DO NOT exceed the factory preset gap by more than 1/4" wider or narrower, contact HWH Customer Service.

4. Problem - With the room retracted bottom, top or both do not seal: A STOP BOLT ADJUSTMENT is needed (See Circle D). Check and adjust as necessary.
